ERIC BLACK
PRELIMINARY FINDINGS
SUMMARY

Re: Fire Investigation – Preliminary Findings Summary

Insured Name: Beartooth Electric Cooperative
Date of Loss: November 15, 2021
Loss Location: 800 Block of County Road 1AB, Clark, WY
Event: Louis L'Amour Fire

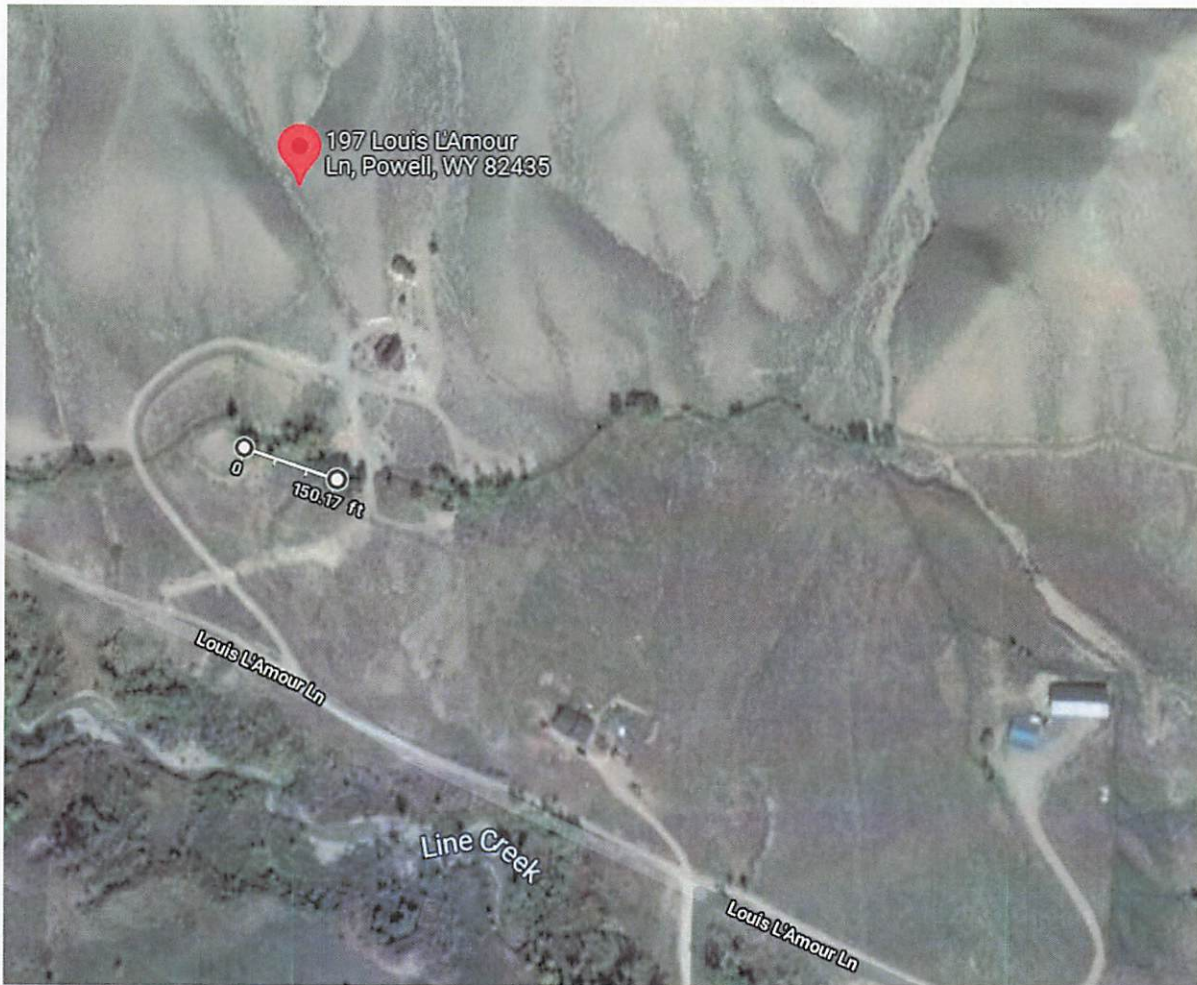
Figure 1 – Screen Capture from Google Maps of 197 Louis L'Amour Ln. Approximate distance from utility pole (0 ft) to area of origin (150.17 ft) shown.

- The powerline and tree branch with arc indicators, identified by CFD, were located approximately 150 feet to the west of the fire area of origin.
- The distance from the powerline to the contact point with nearest tree branch(es) was measured to be between 5 and 6 feet.

- The first evidence of fire spread was at least 150 feet east of the powerline and was in an area near an outbuilding with an outdoor log arrangement for seating.

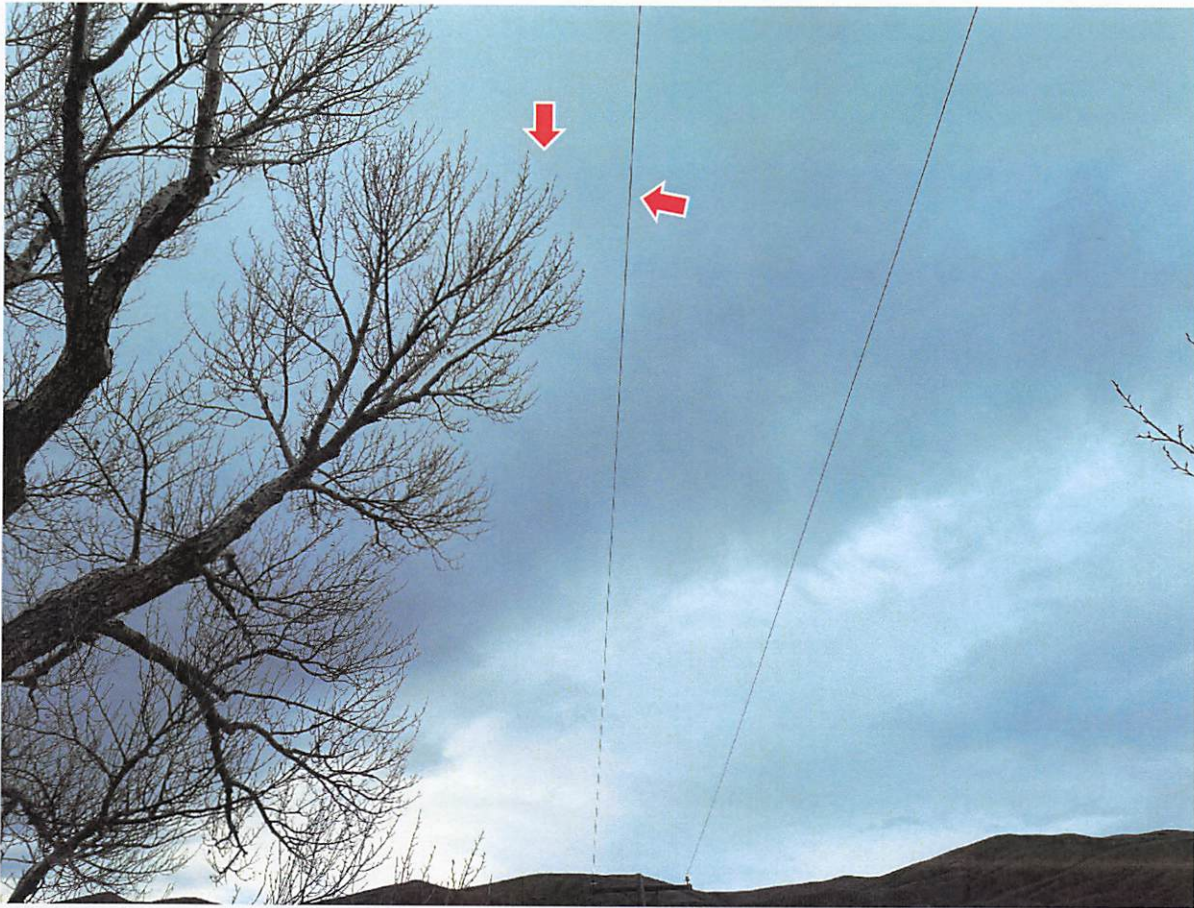
Figure 2 – Subject Powerline and Tree. Mark-up by Knott.

- The tree was located to the east of the powerline and was between the powerline and the area of origin identified further to the east.
- The topography and vegetation were similar between the utility pole for the powerline, and the area of origin for the fire.

- Based on the proximity of the overhead power line to the tree branches and the high winds reported by the first responders, it is possible the power line contacted the tree branch and caused an arcing event; however, with no tripped breakers or reclosures, the exact time of contact cannot be determined. Therefore, it cannot be determined if this arcing event occurred prior to or on the date of loss. Additionally, it is unlikely that embers from an arcing event would travel over 150 feet and ignite dry grass while a charred branch which fell below the tree could not.

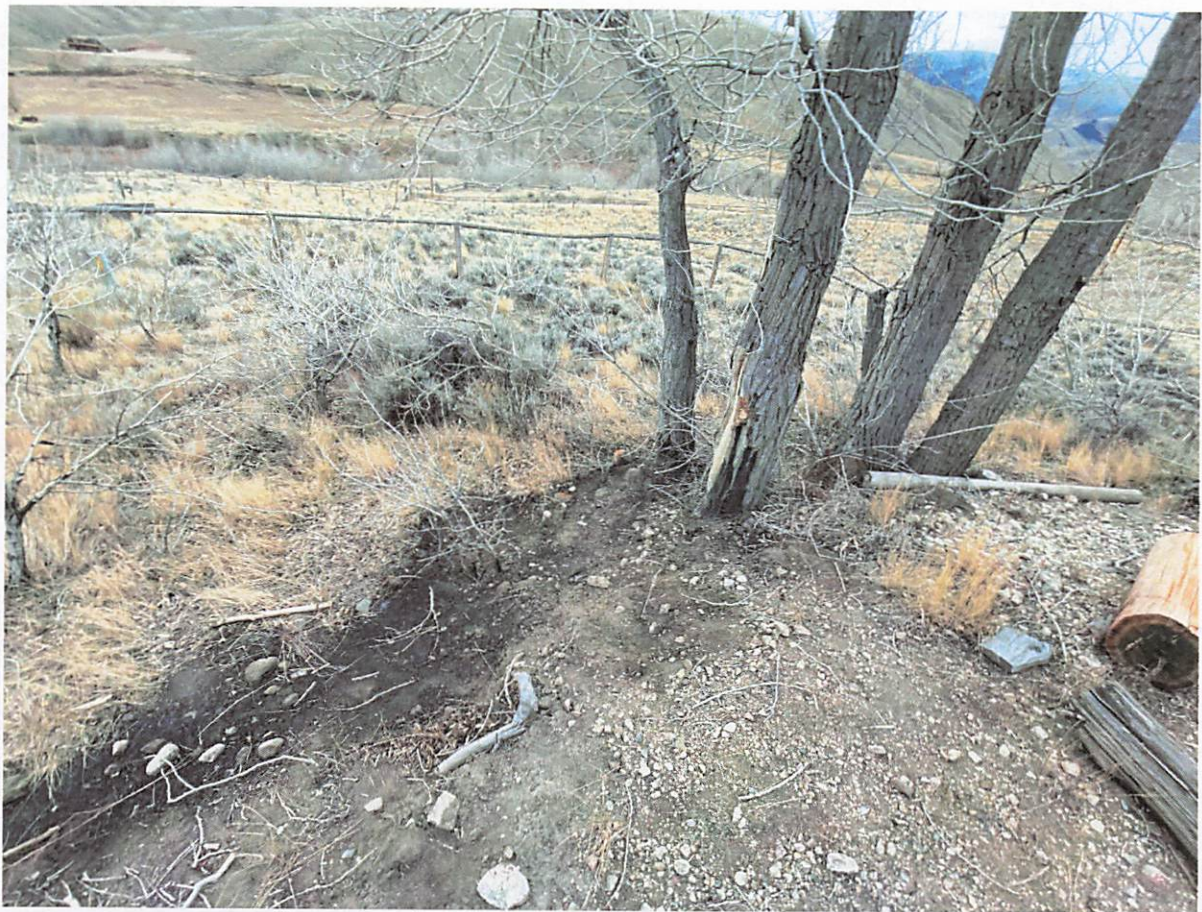
Figure 3 – Area of Origin Location Near Log Seating.

- The area of origin was determined to be to the south of the main residence at 197 Louis L'Amour Lane near the various out buildings and seating areas through the property.

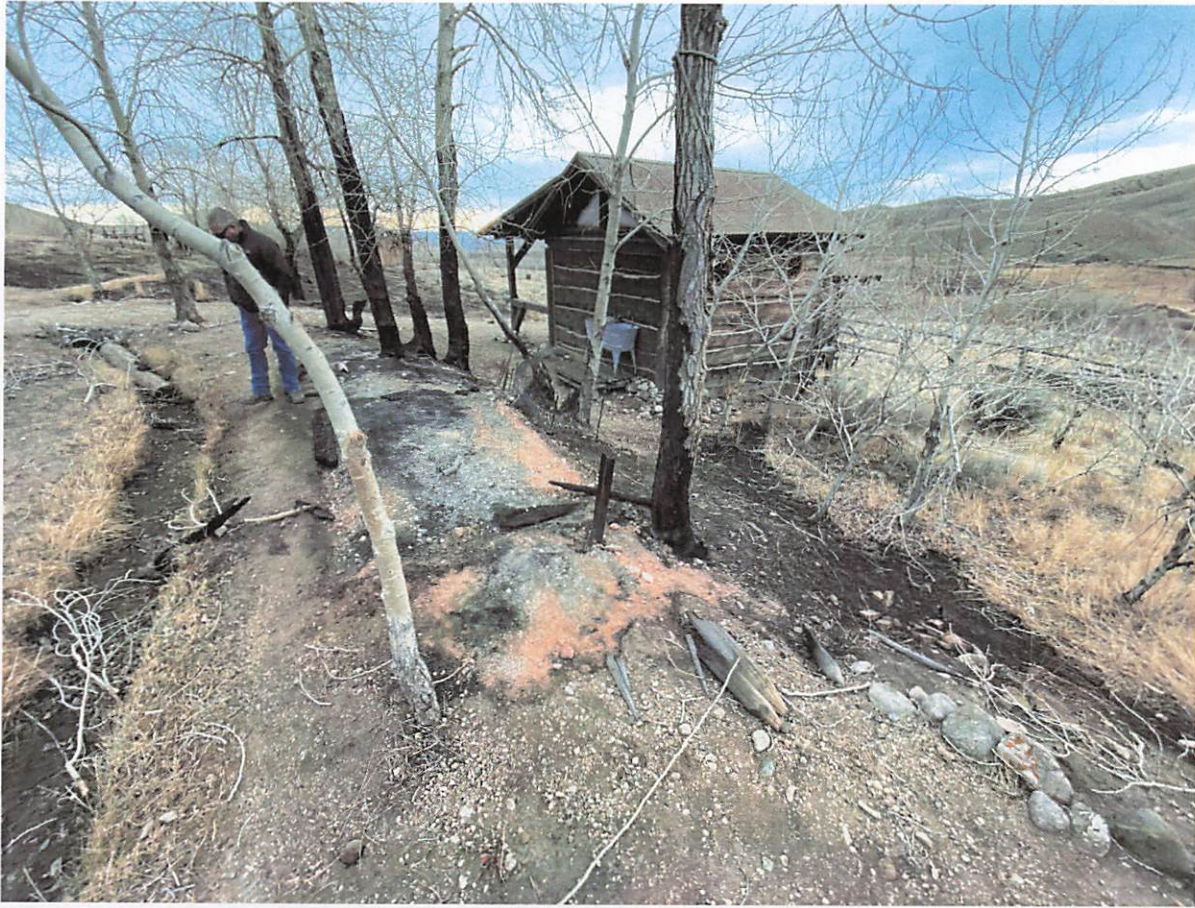
Figure 4 – Area of Origin Location Near Outbuilding

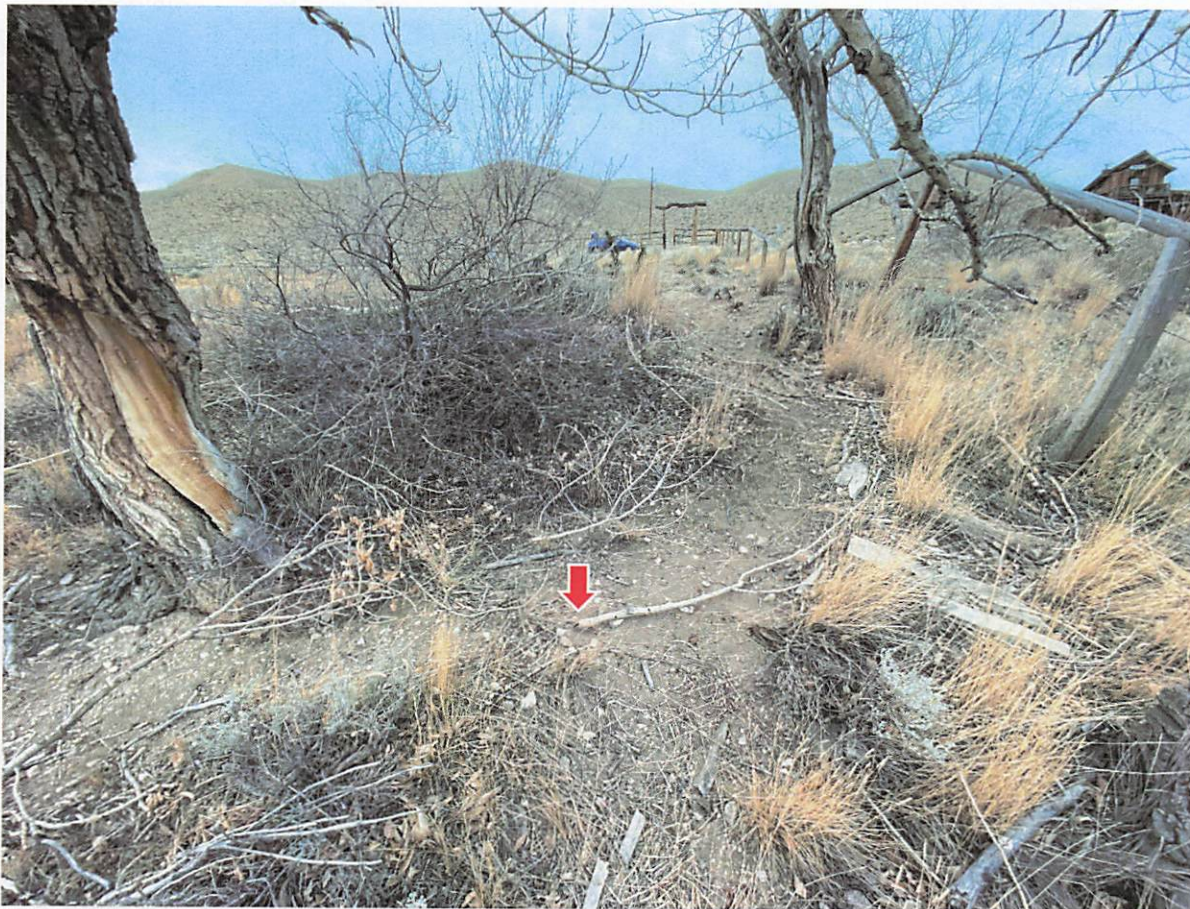
Photograph 5 – Charred Branch Found Location on Ground. Mark-up by Knott.

- During the investigation, it was undetermined how the charred branch separated from the tree and passed through, or beneath, the bare tree canopy, to arrive at its final rest position in an unburned area at least 75 feet to the east.

- During the investigation, it was undetermined why the charred branch, which would have been a competent ignition source, failed to ignite the dry grass beneath the tree where the charred branch was found.

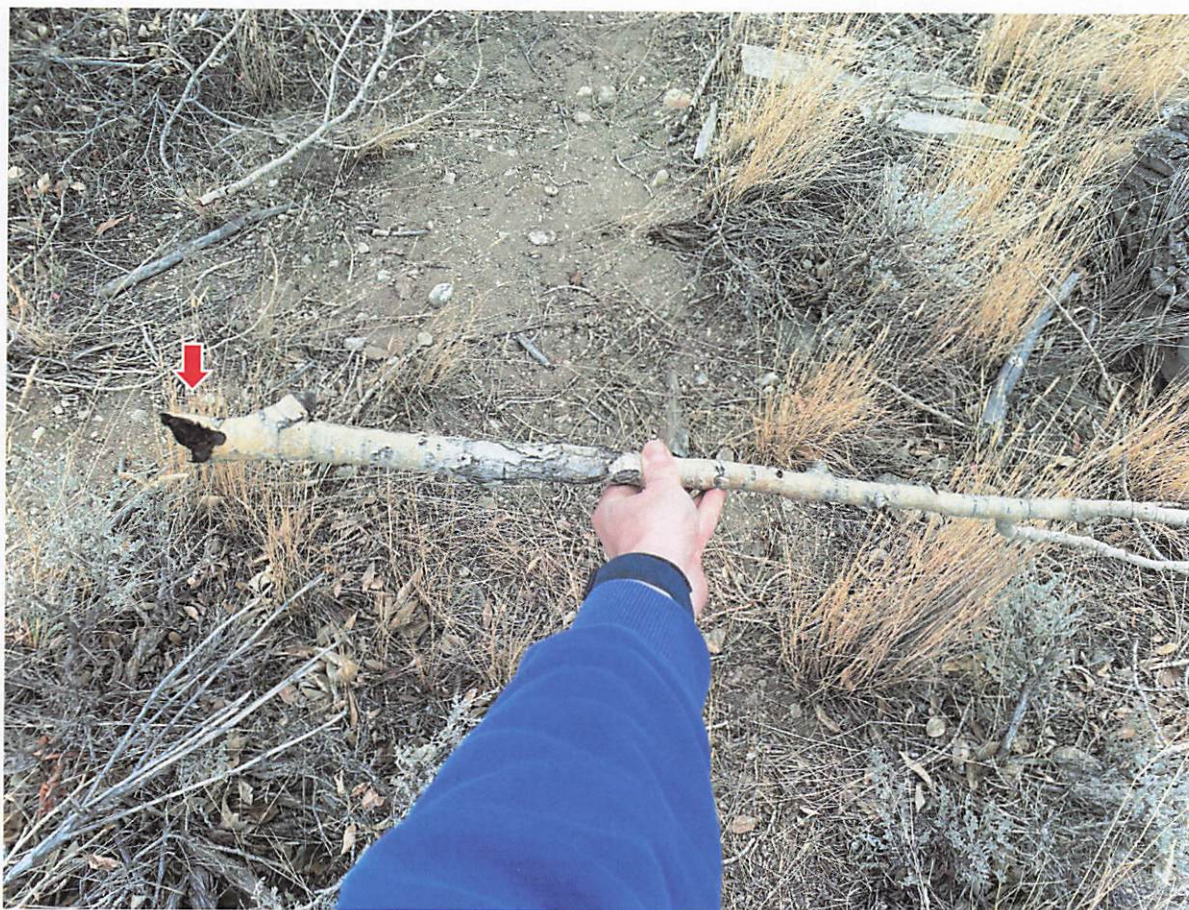
Figure 6 – Charred Branch. Mark-up by Knott.

- Knott disagrees with Mr. Nate Hoffert that the embers from an arcing event, 150 feet to the west of the area of origin, would be capable of maintaining enough energy to ignite the dry grass while the charred branch found beneath the tree was unable to ignite the grass around it. The charred branch would be a much larger energy source and would maintain heat better, making it a more competent ignition source than airborne embers.

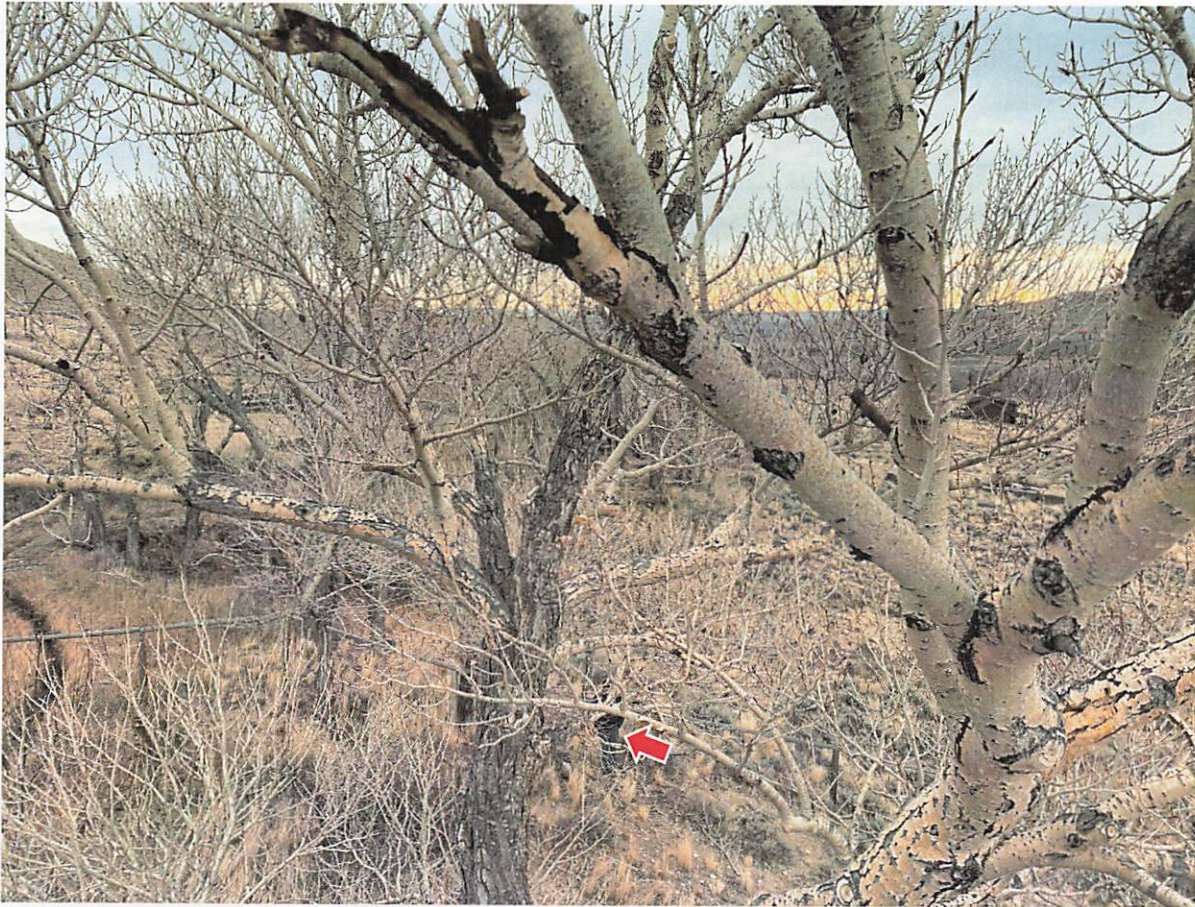
Photograph 7 – Location of Charred Branch as Viewed from Potential Area of Separation. Mark-up by Knott, arrow shows individual standing where branch was found on the ground.

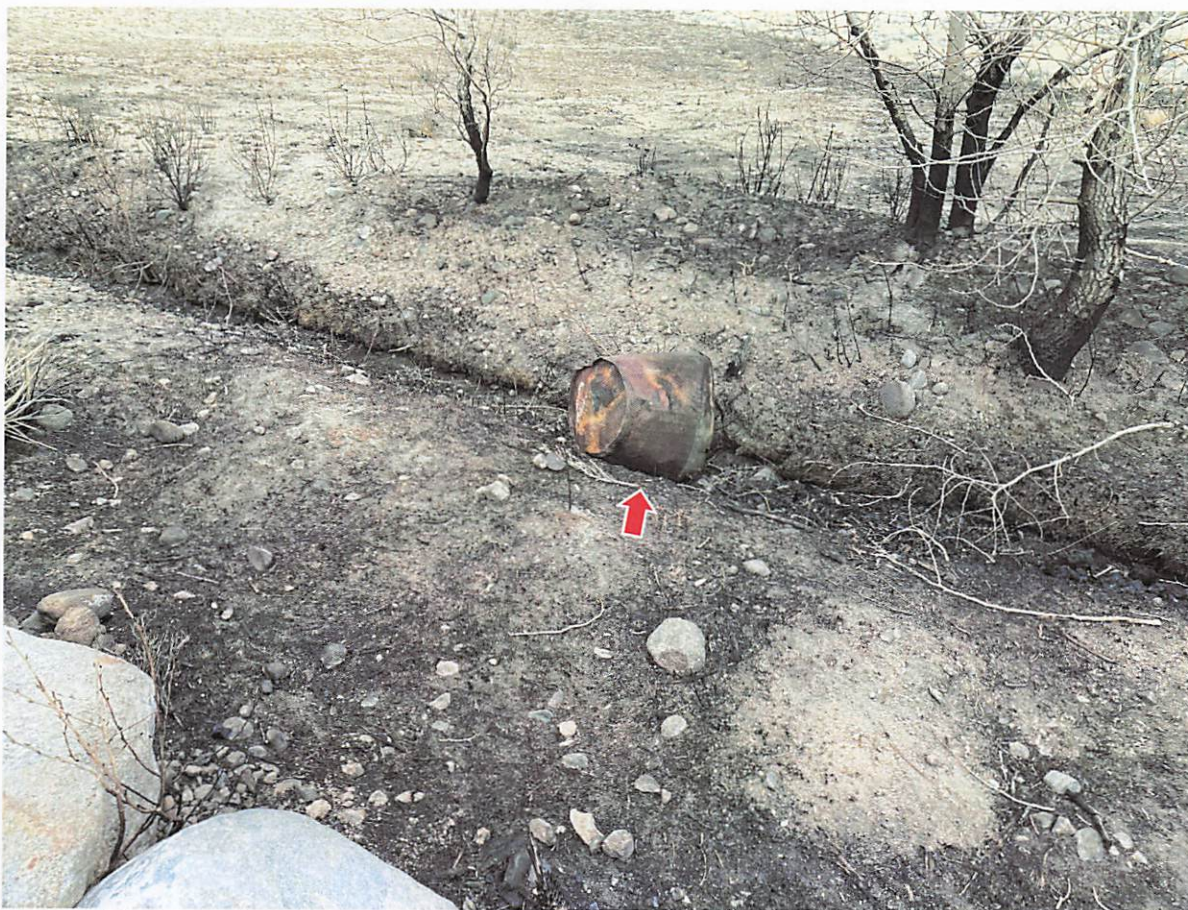
Photograph 8 – Fire bucket Found on East Side of Property. Mark-up by Knott.

- A metal trashcan was found blown over and lodged in a ditch toward the eastern section of the area of origin. The trashcan contained fire patterns which were consistent with the trashcan having been used as a makeshift firepit (fire can or fire bucket). If the fire bucket contained coals from an improperly extinguished fire, the fire bucket would be a competent ignition source for the surface fuels located in the area of origin.

- During the investigation, it was undetermined when the last use of the fire bucket occurred; however, hunters were known to occasionally use the area, and the presence of an unknown vehicle (black truck) may indicate recent activity by unknown persons at or near the area of origin.
